# Manhole Inspection Summary

Manhole # S03YY1008MH

Insp Date: **8/14/06 12:00 AM**

**Location** Address: **3904 PARKINGTON AVE**

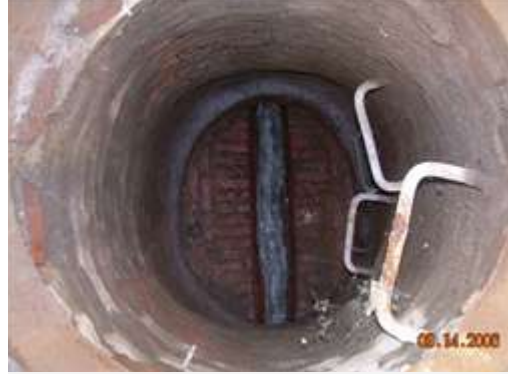
Top View

Evidence of surcharge - Bench debris.

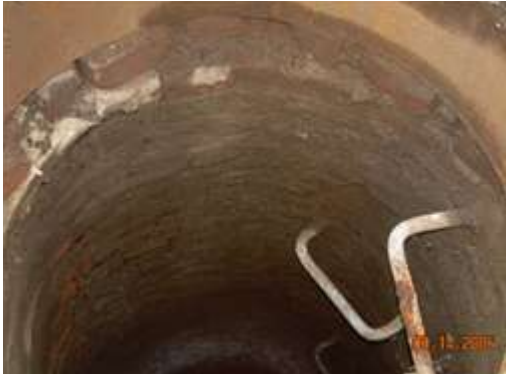
Defect

☒ **Leaks**

Condition: ☐ Sound ☐ Cracked ☐ Root Intrusion ☒ **Loose Brick** ☒ **Deteriorated**

Infiltration: ☐ None ☒ **Joint** ☐ Cracks ☐ Mortar ☐ Roots ☒ **Wall**

Frame leaks. Frame offset. Adjustment deterioration, loose brick and infiltration. Corbel and Barrel infiltration.

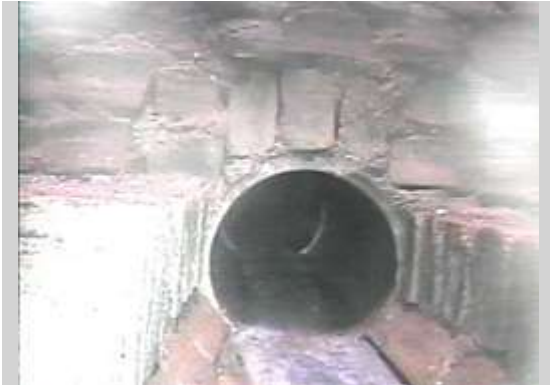
### 8 in. Circular Gravity Sewer Pipe Out @ 12 O'Clock

Condition: ☐ Sound ☐ Cracked ☐ Root Intrusion ☐ Loose Brick ☒ **Deteriorated**

Condition: ☐ Sound ☐ Cracked ☐ Root Intrusion ☒ **Deteriorated** ☐ Leaks ☐ Debris

Barrel deterioration and infiltration. Channel deterioration.

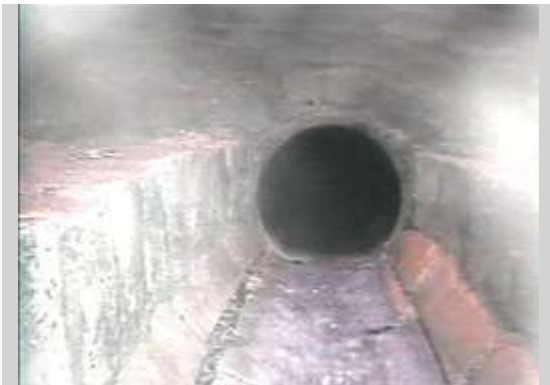
### 8 in. Circular Gravity Sewer Pipe In @ 6 O'Clock

Barrel deterioration and infiltration. Channel deterioration.
